Hourglass Crown Zachary Miller Stability: Poor HS:190 Layer Notes: Bridgers 02/28/2020 - 11:10am Air Temperature: -2°C 135-123cm: 1st failure layer 102-60cm: 2nd failure layer MT Co-ord: 45.83300N, -110.93770W Sky Cover: CLR 102-60cm:Problematic layer Elevation: 8250 ft Slope Angle: 40° Precipitation: NO 5-0cm: 3rd failure layer Aspect: E Wind Loading: Wind: W Light Breeze Specifics: Recent activity on similar slopes; Ski tracks on slope ρ Crystal Stability tests & Layer Size Moisture kg/m^a Form 1 190 180 1

Advisory Region Bridger Range Longitude -110.94W Latitude 45.83N

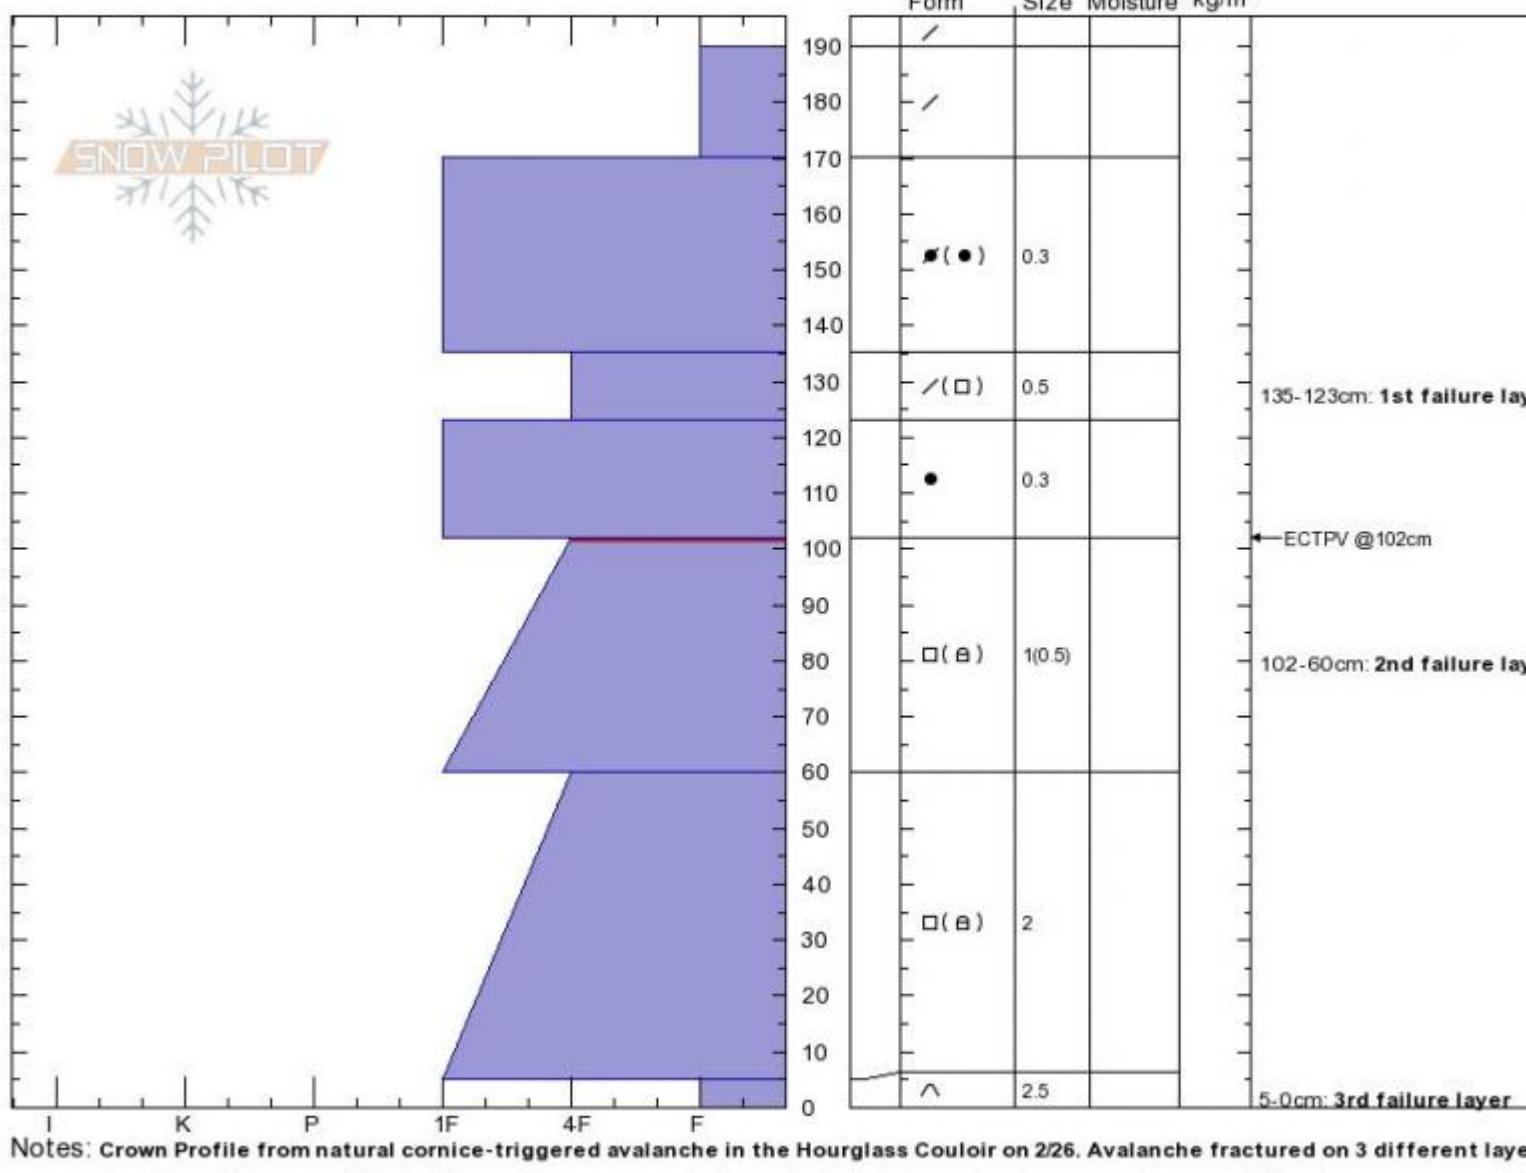
breaking at the ground. Each failure plane was very similar - wind-packed rounds above a weaker layer of facets.
