Advisory Region Northern Gallatin

Forecast link: <u>GNFAC Avalanche Advisory for Wed Dec 27, 2017</u> Northern Gallatin, 2017-12-27

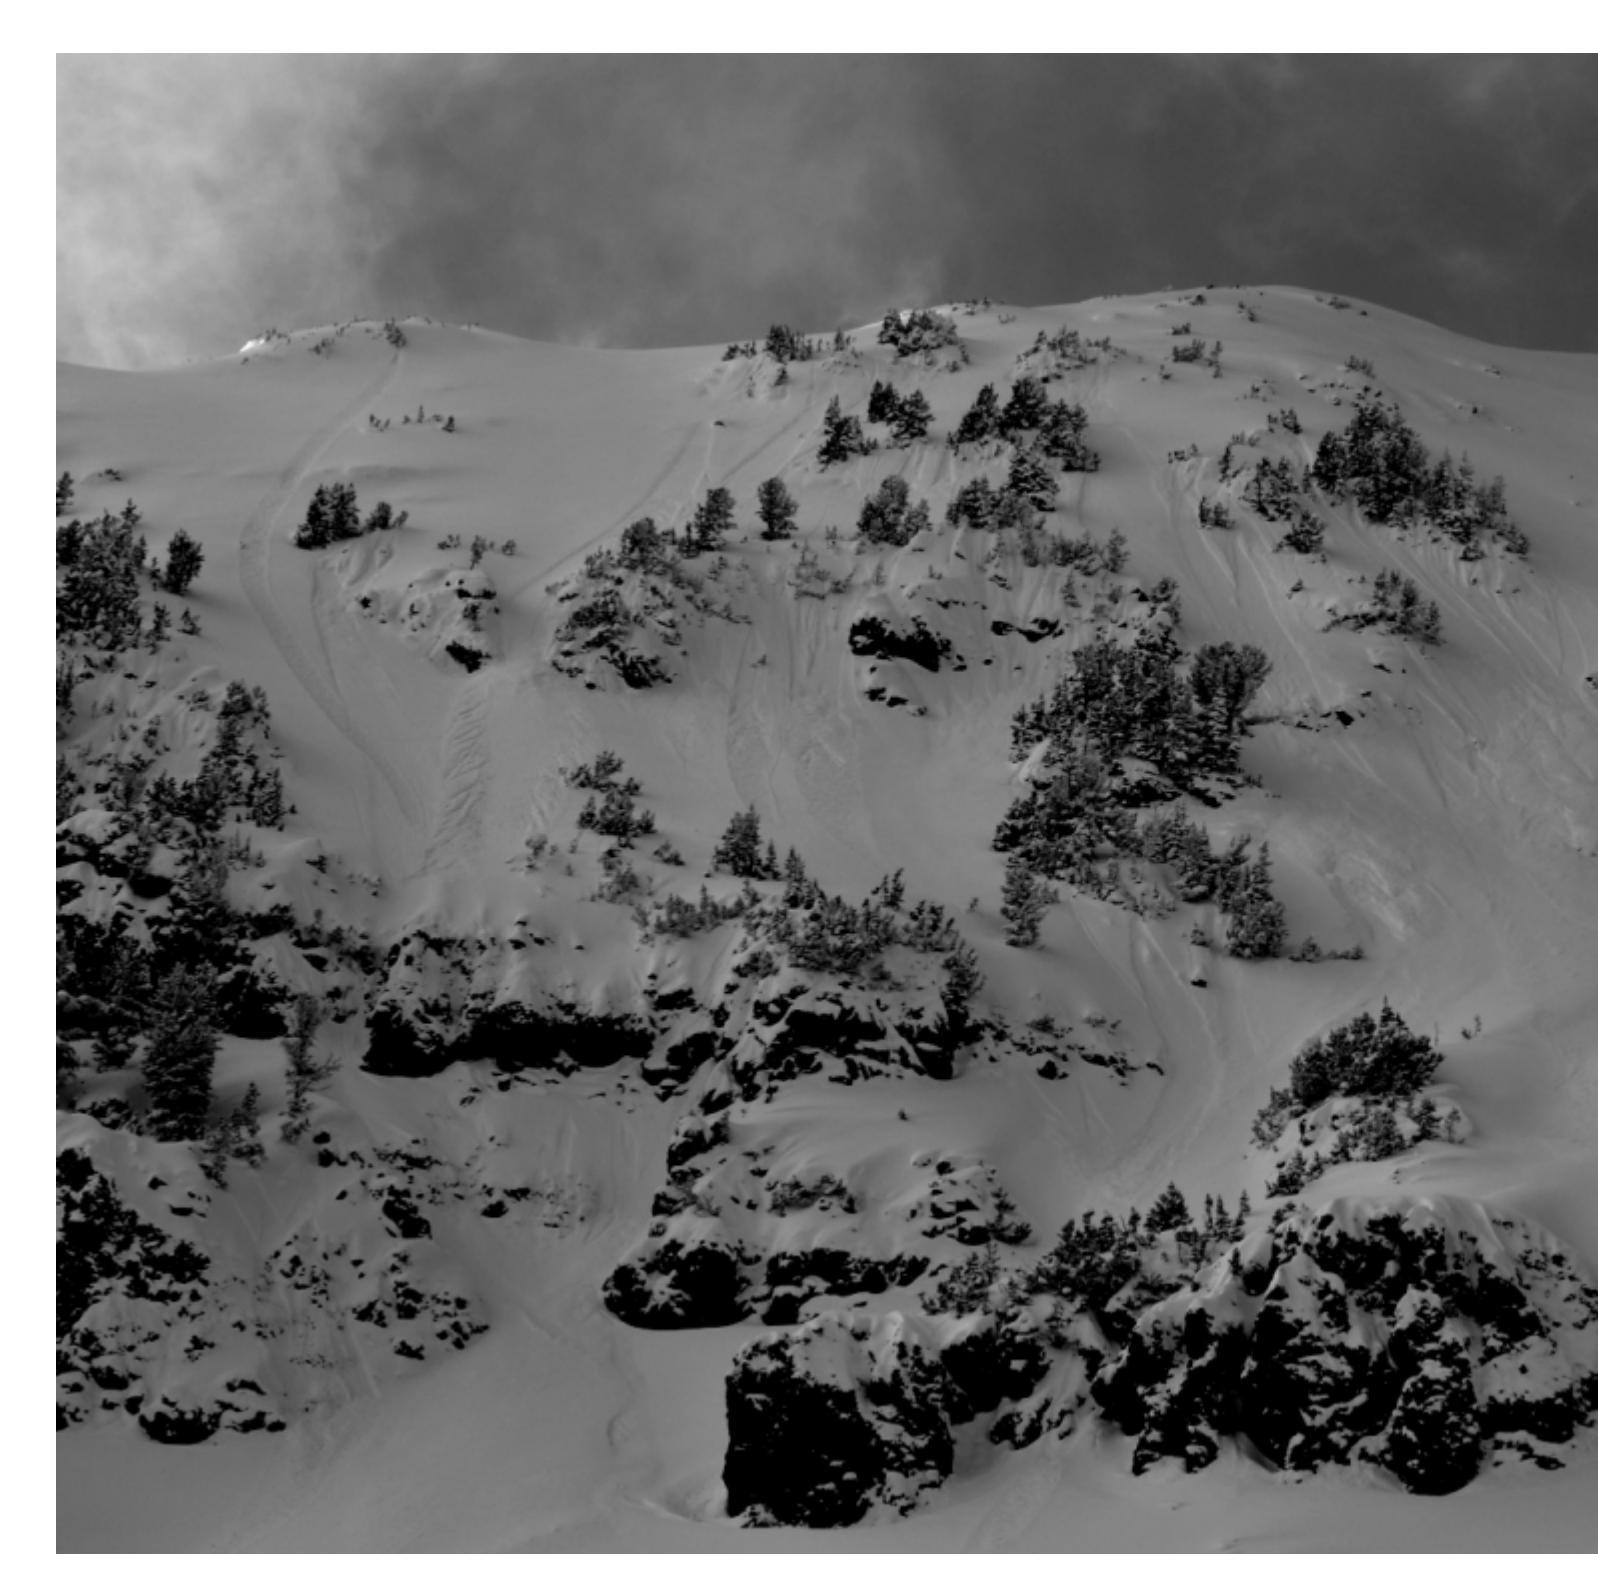
Skiers noted that the east face of Mt. Blackmore was largely unaffected by the wind and had many natural dry loose sluffs. They observed no evidence of natural activity from deeper seated instabilities. Photo: B. VandenBos
